Manhole Inspection Summary

Manhole # S15AA_024MH

Insp Date: **5/6/09 3:17 PM**

Location Address: **919 CLAMONT AVE**

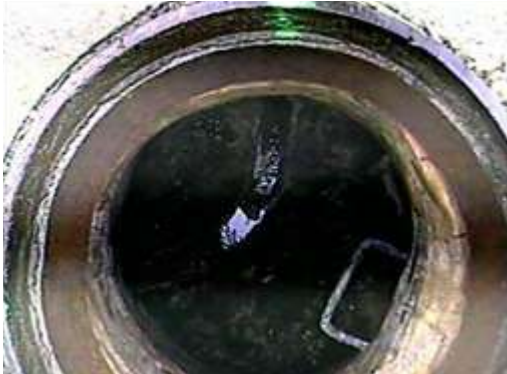
Top View

Frame Offset: **2** (in.) Condition: ☒ Sound ☐ Cracked ☐ Leaks

FRAME OFFSET

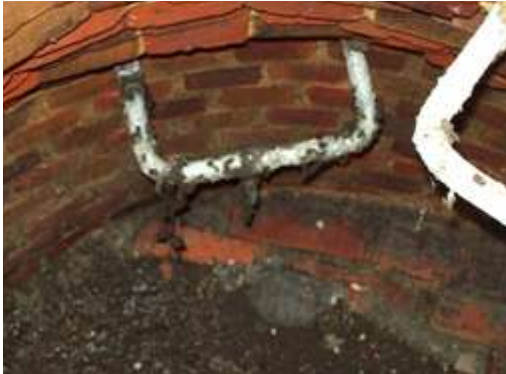
Defect 2

Surcharge ☒ **Evidence Of Surcharge** Depth: **1** (ft.) ☐ Active Surcharge Present

EVIDENCE OF SURCHARGE

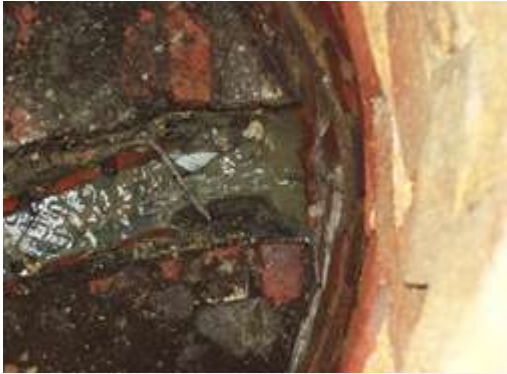
Defect 1

Condition: ☐ Sound ☐ Cracked ☐ Root Intrusion ☐ Deteriorated ☐ Leaks ☒ **Debris**

CHANNEL AND BENCH DEBRIS

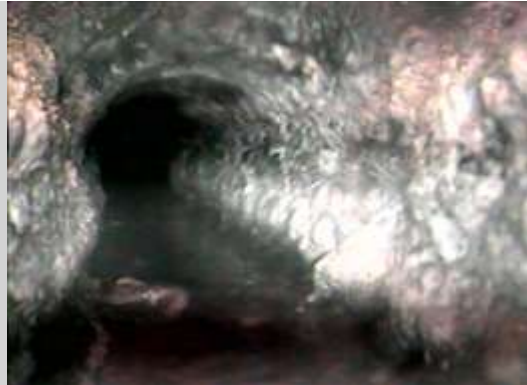
12 O'Clock Outflow

8 in. Circular Gravity Sewer
Pipe Out @ 12 O'Clock

Deposits: ☐ None ☐ Mud ☒ **Sludgy** ☐ Debris ☒ **Grease**

Silt Depth: **2** (in.) Deposits Extent: **Light**

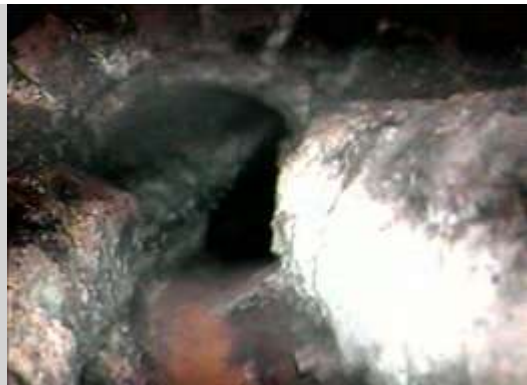
9 O'Clock Inflow

10 in. Circular Gravity Sewer
Pipe In @ 9 O'Clock

Deposits: ☐ None ☐ Mud ☒ **Sludgy** ☐ Debris ☒ **Grease**

Silt Depth: **2** (in.) Deposits Extent: **Light**
